## **FLOWER GARDEN BANKS NATIONAL MARINE SANCTUARY DRAFT - POST HURRICANE IKE QUICK LOOK CRUISE REPORT**

OCTOBER 17, 2008

Prepared by Emma L. Hickerson

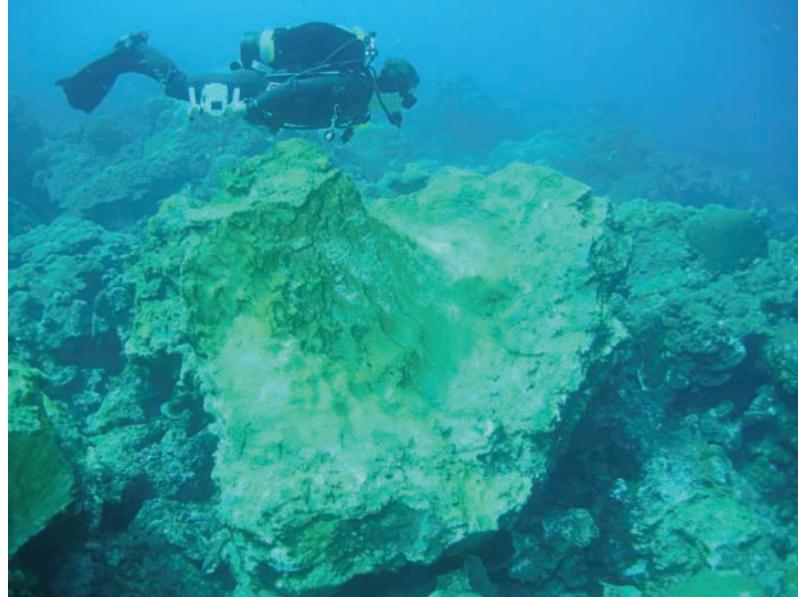
Figure 6. *Eric McHugh hovers over a large upturned boulder coral very close to EFGB mooring #2 (October 2008).*

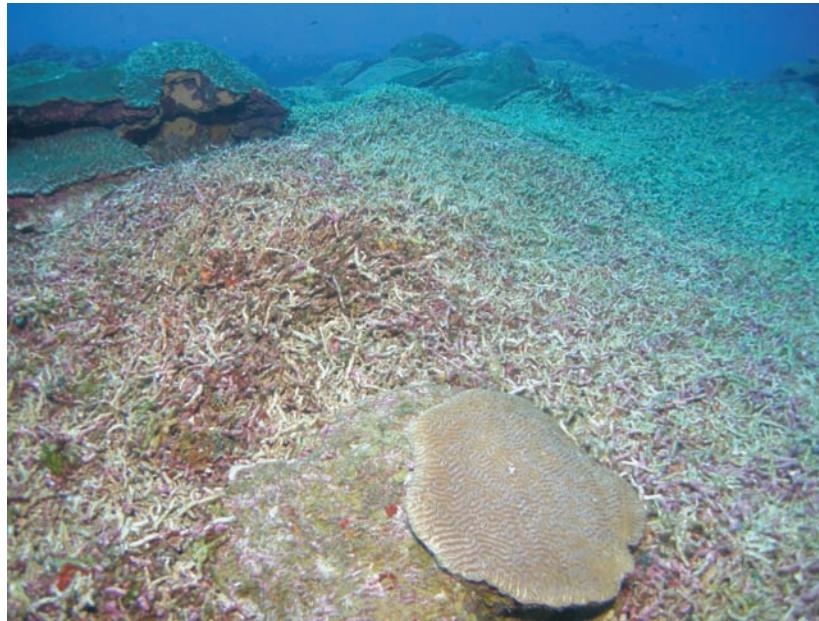
Figure 7. *Field of yellow pencil coral (*Madracis mirabilis*) are seen broken in place due apparently to downward forces produced by the storm. This field was in similar condition after Hurricane Rita in 2005, but had recovered substantially by August 2008, prior to Hurricane Ike (October 2008).*

In August 2008, the FGBNMS research team dove on the *Madracis* field at EFGB and had commented on the healthy condition observed – an indication that the species was recovering from the injury after Rita in 2005. We have also been observing the regrowth of the large barrel sponges, *Xestospongia muta*, since Rita. Based on the post-Rita and Ike observations on the reef crest at the Flower Garden Banks, we have a better understanding of what has shaped the reef over thousand of years, what is driving the shape of the individual colonies, and the level of resilience and recovery capabilities this coral reef has.

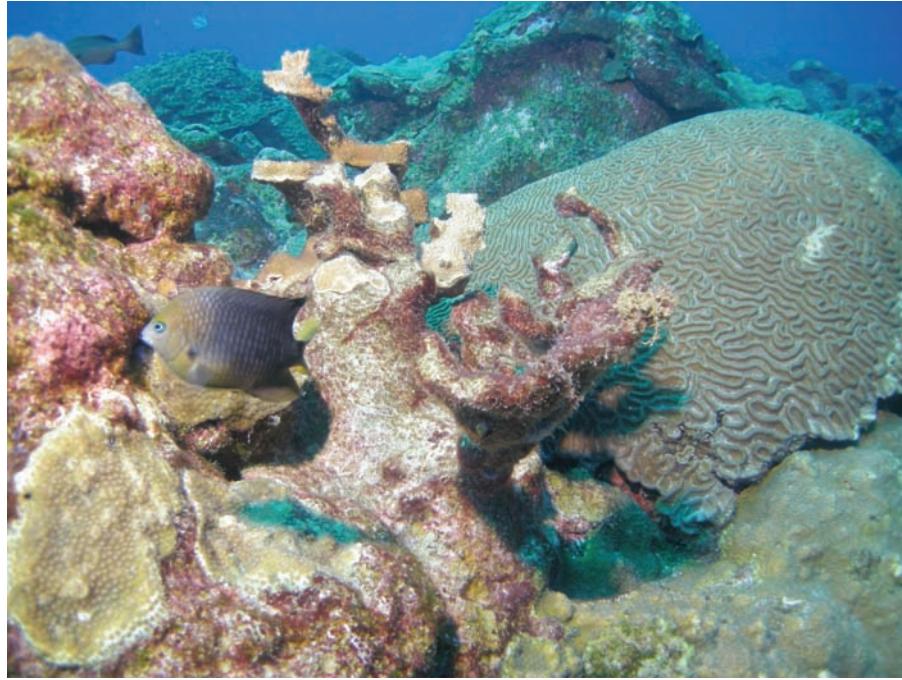
Figure 9. *The only living Acropora palmata known at the East FGB – north side has been farmed by threespot damselfish. South side of colony appears in good health. Branches of colony were lost during storm (October 2008).*

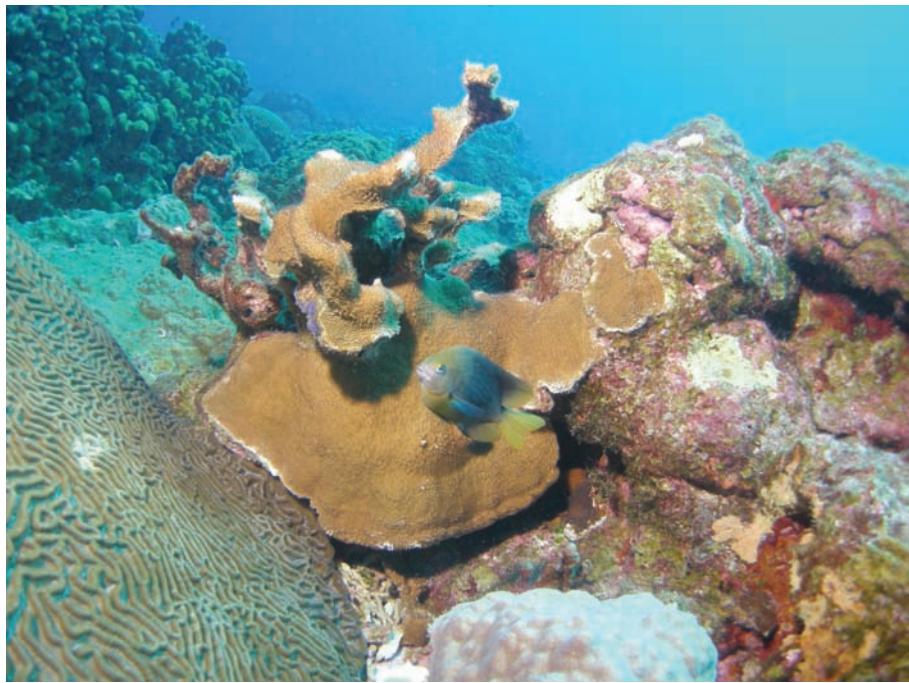
Figure10. *South side of the East FGB A. palmata appears to be relatively healthy.*

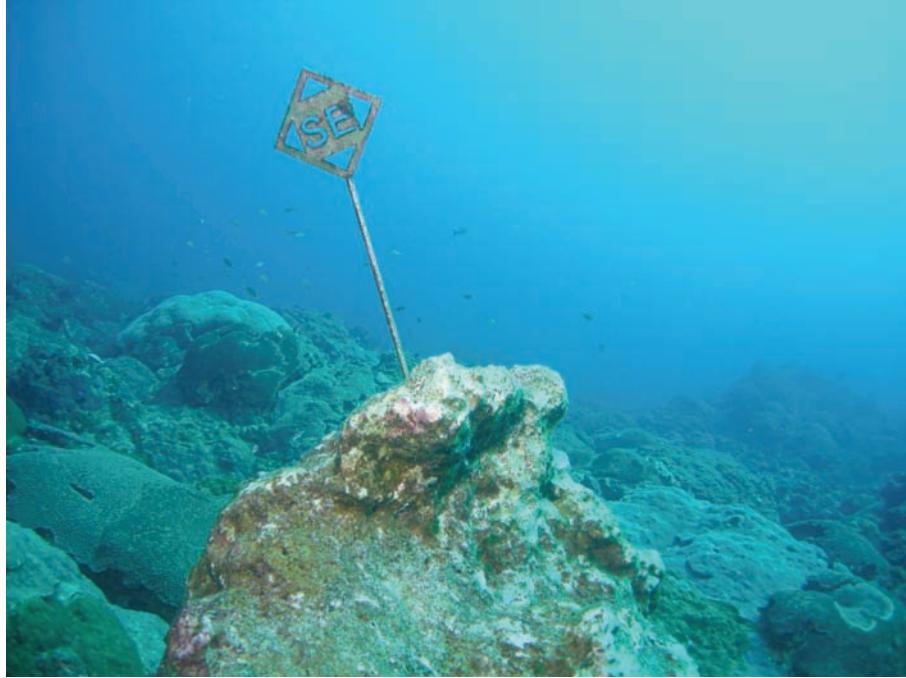
The SE corner post on the long-term monitoring study site at EFGB was in place, although bent. It is unknown at this time what the status is of the other corner posts. Multiple long-term monitoring stations were observed, but many were bent. The study site at WFGB was not surveyed. YSI and Seabird instruments were partially buried and need to be lifted and repositioned on the sandflats at EFGB#4/5 and WFGB#2. The acoustic receivers were both still intact and functioning.

Figure 12. SE corner marker of the study site at the East FGB, slightly askew (October 2008).

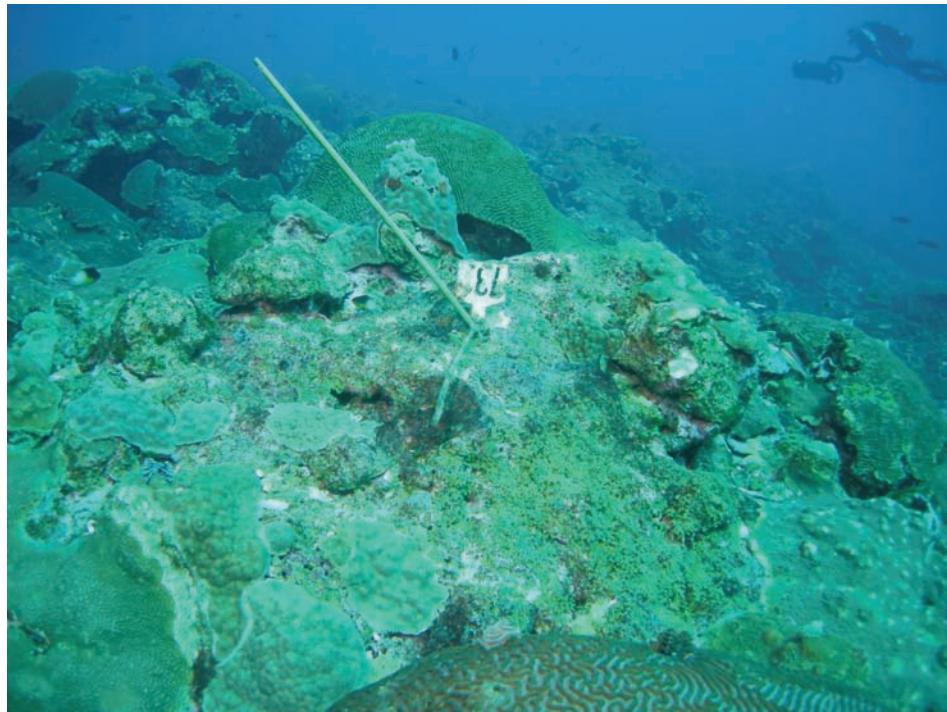
Figure 13. Long term monitoring repetitive station pin, bent in place (October 2008).

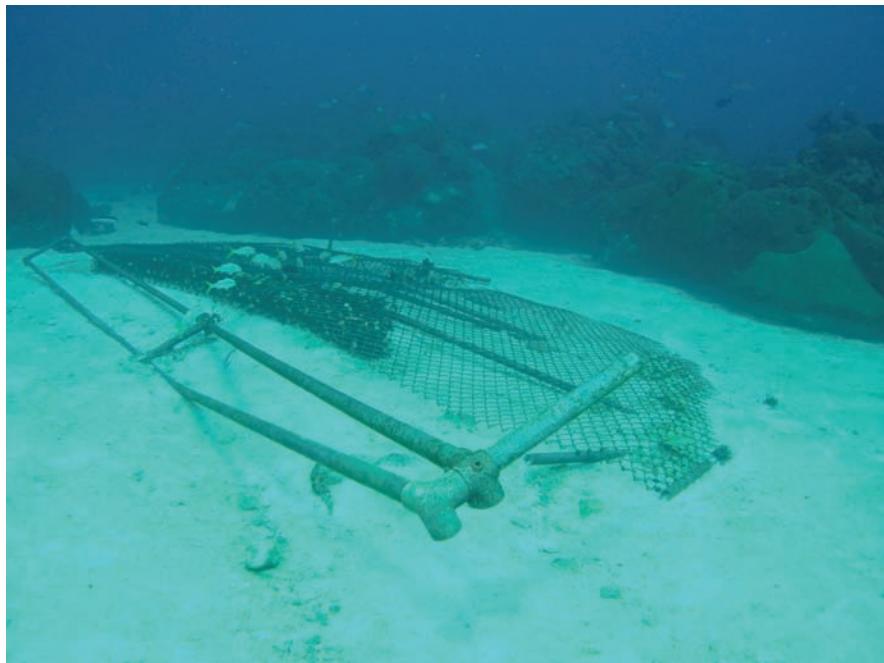
Figure 14. *Remains of recruitment rack, study site for University of Calgary student, Sarah Davies (October 2008).*

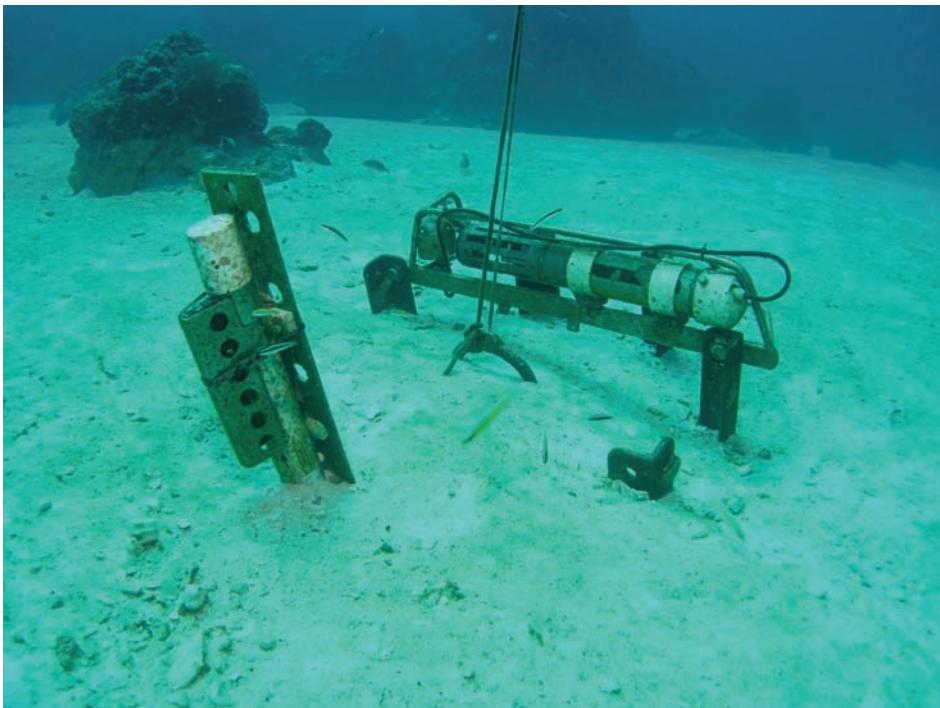
Figure 16. *YSI and Seabird water quality instruments at EFGB (October 2008).*

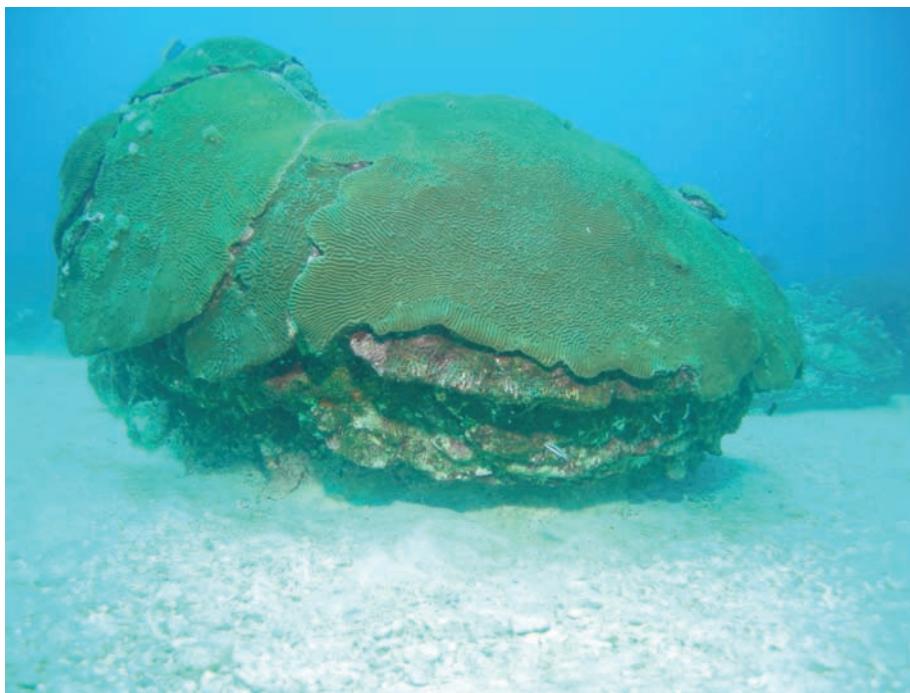
Figure 17. *Scouring around a large coral outcropping on the sand flat between buoy numbers 4 and 5 at the EFGB (October 2008).*

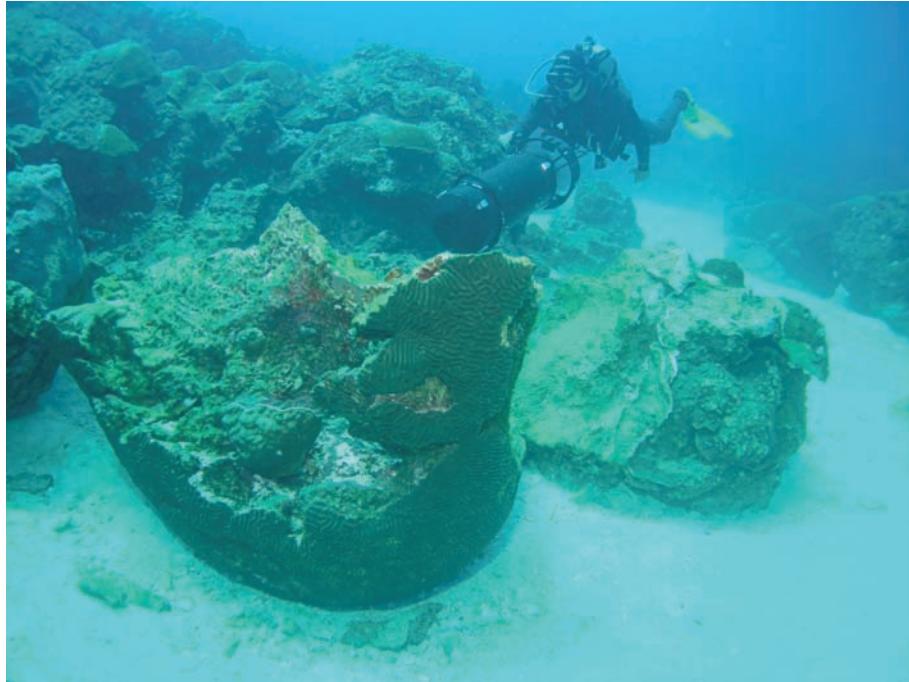
Figure 18. *Captain Darrell scooters over a large brain coral colony (Colpophyllia natans) toppled in the sand flat (October 2008).*

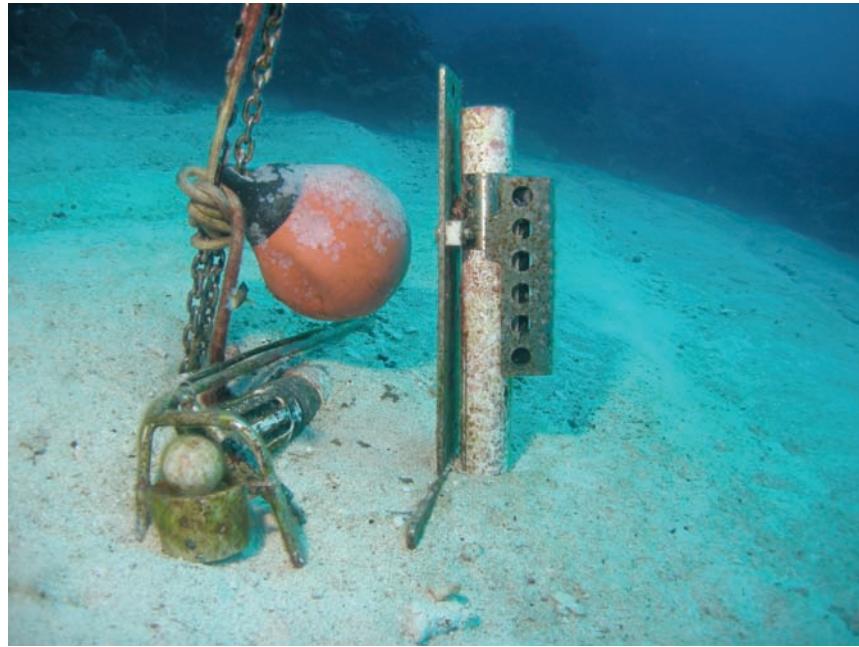
Figure 19. *The YSI and Seabird water quality instrument partially buried in sandflat at buoy #2 on WFGB (October 2008).*

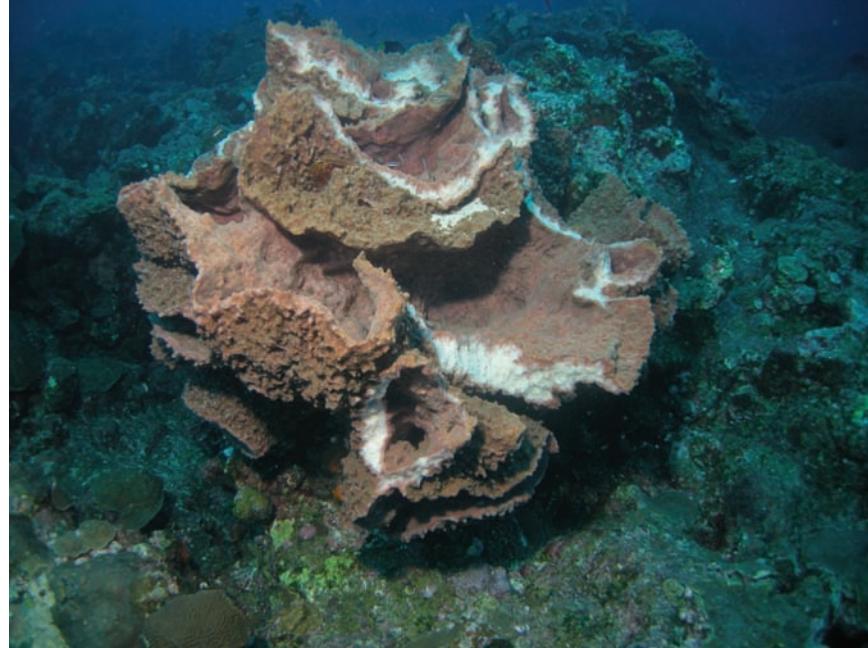
Figure 20. *Giant barrel sponge, Xestospongia muta, exhibiting exposed tissue where portions of the barrels have been sheared off during the storm. This is the sponge that is on the southeast side of the West FGB Acropora palmata (October 2008).*

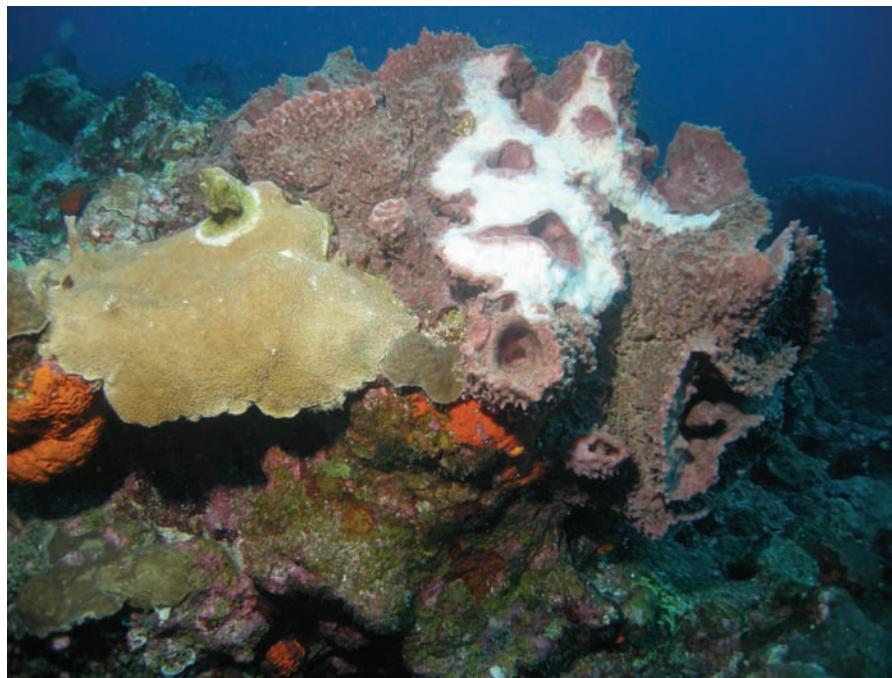
Figure 21. *The only known living Acropora palmata on the West Flower Garden Bank, tucked in behind the sponge as shown in Figure 20 (October 2008).*

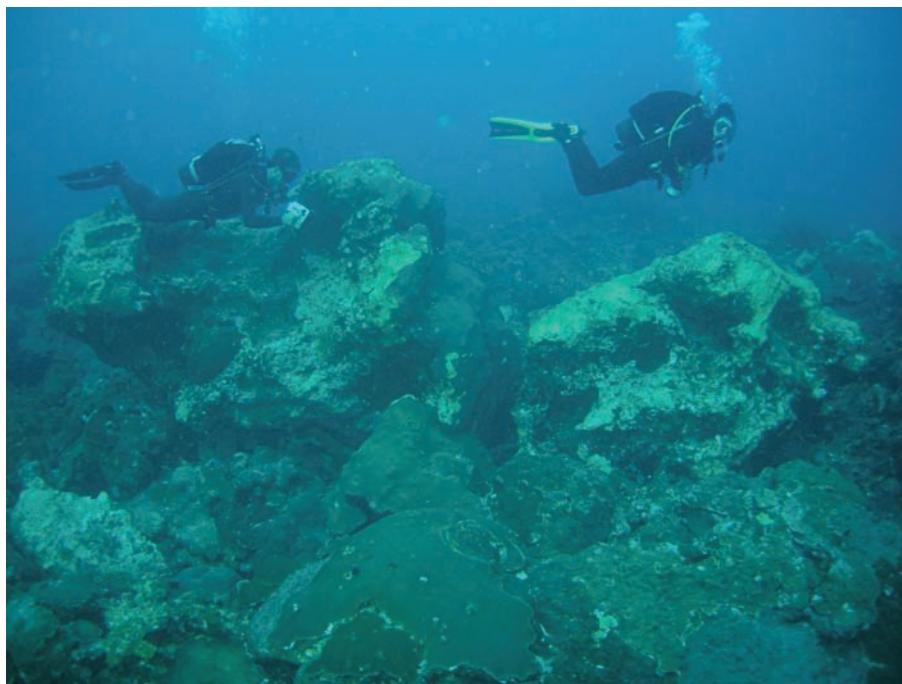
Figure 25. *Eric McHugh and Marissa Nuttall hover over large boulders of dislodged corals close to the WFGB#2 mooring (October 2008).*

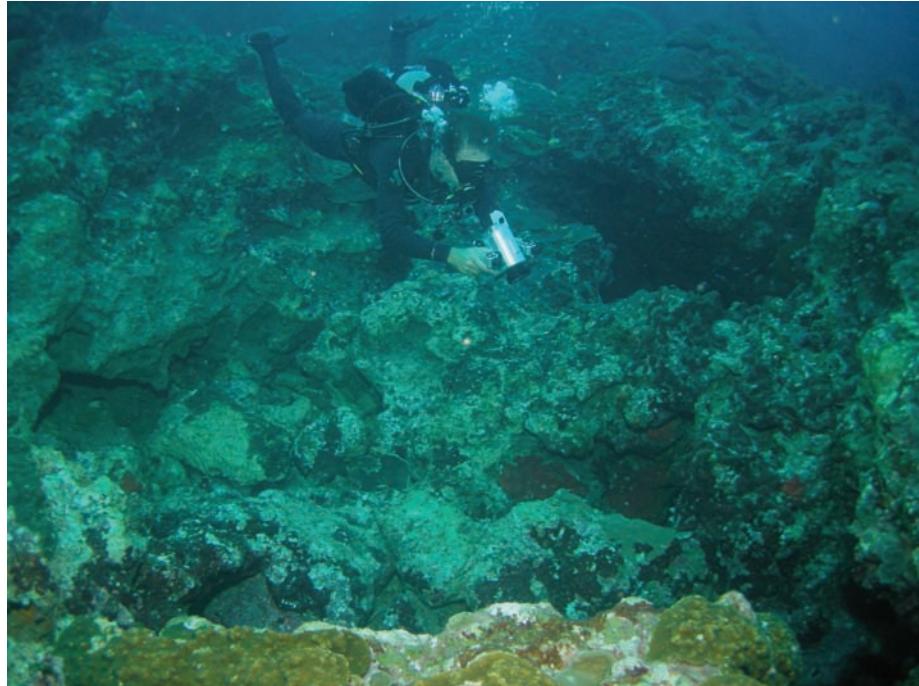
Figure 26. *Eric McHugh shoots video inside a crater left behind by a dislodged boulder coral (October 2008).*

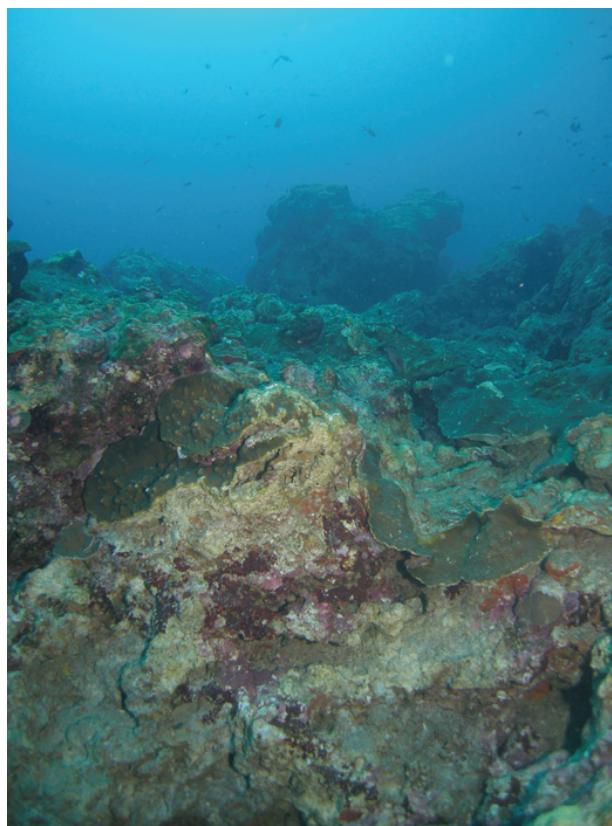
Figure 27. *Inside the crater looking southwest towards the coral colony that was dislodged, approximately 25 feet away (October 2008).*

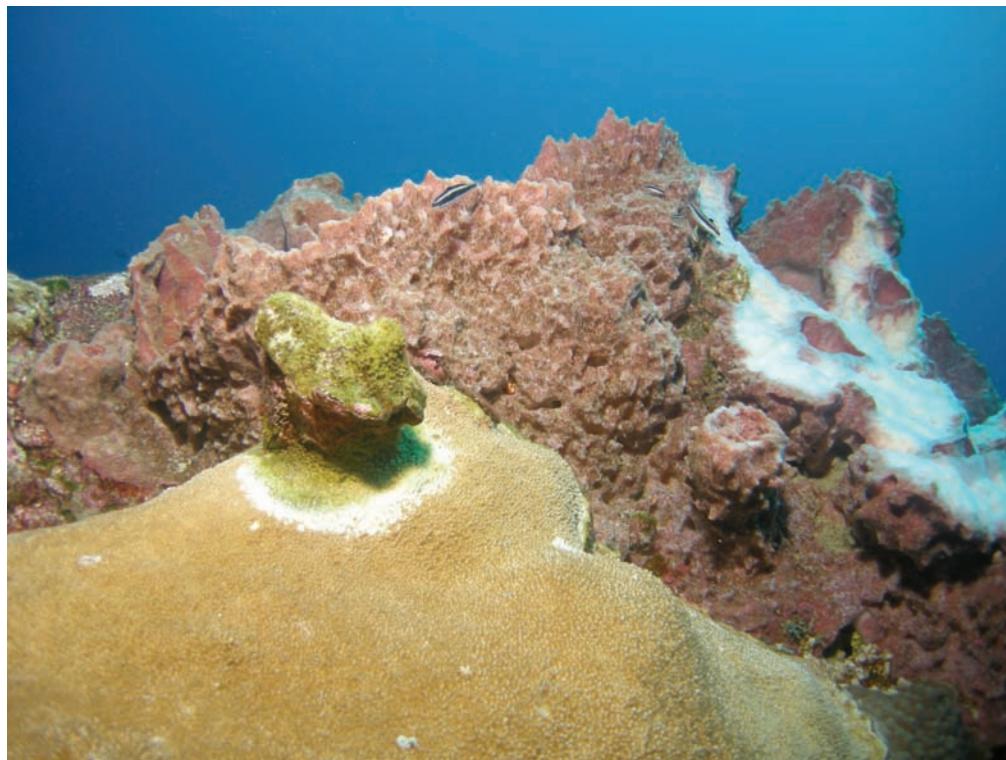
Figure 28. *On the right the exposed tissue of the sponge caused by shearing during Hurricane Ike is seen, the left side of the sponge shows the recovery of barrels that were sheared off in September 2005 during Hurricane Rita. In the foreground, details of the malady exhibited around the “horn” of the WFGB Acropora palmata is shown (October 2008).*
